Customer Support Bulletin

Number: CSB- 9802003

Subject: Inserting last I/O module into a Accelar 1200 chassis

Product: XLR1200

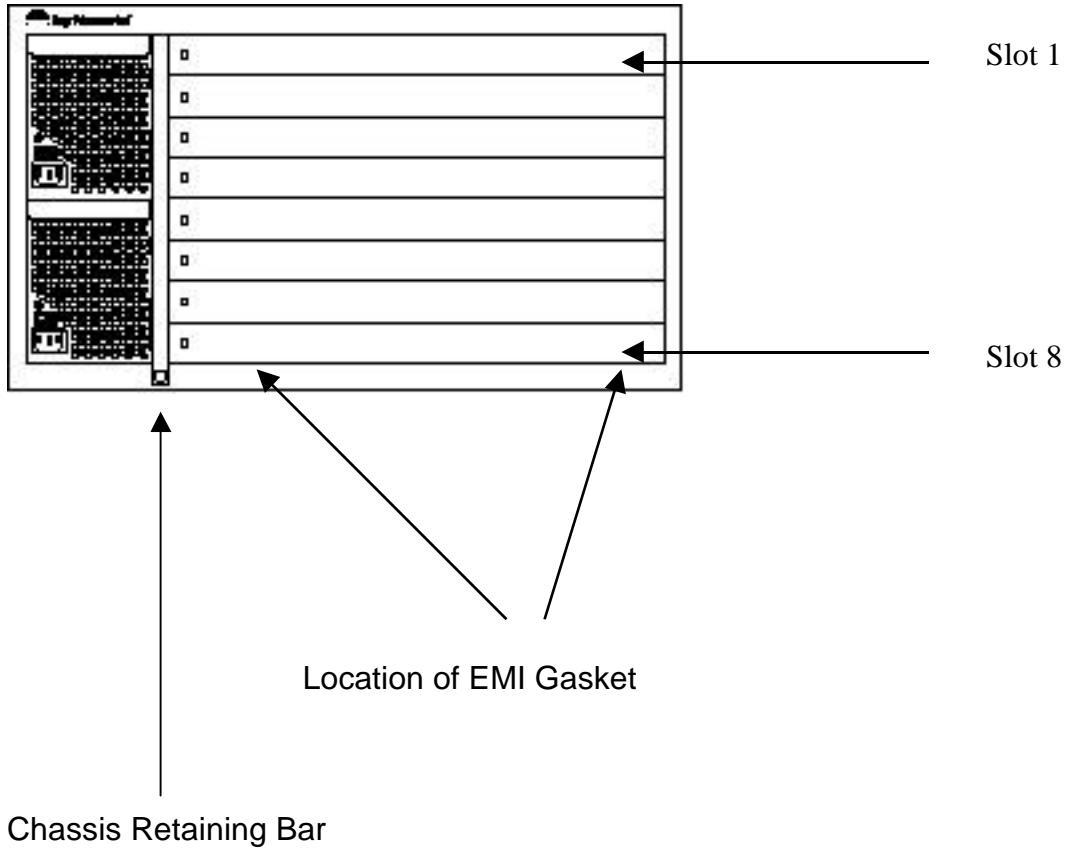
Accelar 1200 Chassis
Figure 1.

When installing all eight cards into the Accelar 1200 chassis (2 Silicon Switched Fabric cards and six I/O modules), there may not be enough vertical tolerance to insert the final I/O module. The beryllium EMI gasket on the chassis located under slot 8 may not allow for the proper vertical clearance. When installing the last card in a fully populated 1200 chassis and you incur resistance as the module is being inserted then you will need to remove the EMI gasket. If no resistance is incurred then there is no need to remove the EMI gasket.

1. See diagram figure 1 on page 2 of this CSB.
2. Turn power off and remove the AC power cord.
3. Remove chassis retaining bar, cover plates, I/O modules and SSF modules.
4. Using a pair of needle nose pliers and pull the EMI Gasket from the chassis located on the bottom of slot 8.
5. Reinstall the I/O modules and SSF modules starting with slot 1 and work your way down.
